**Sunset Ridge Villas**  
**Glenwood Springs, CO**

Report #: 51217-0  
Beginning: January 1, 2025  
Expires: December 31, 2025

**RESERVE STUDY**  
**"Full"**

June 28, 2024

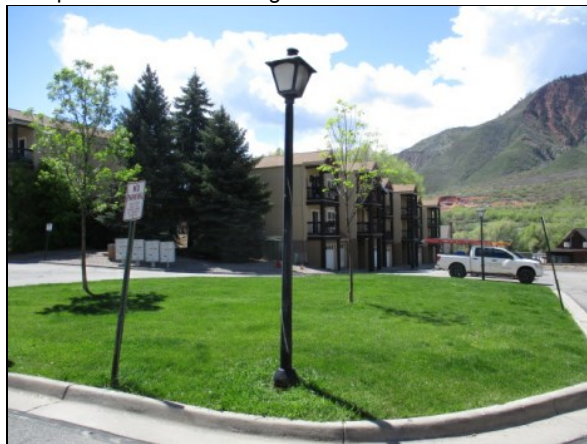
Comments: Pole lights determined to be in poor condition typically exhibit moderate to advanced wear or other signs of age. Timeline for replacement can often be determined by outdated style. At this stage replacement for aesthetic reasons may still be warranted even if lights are functional. Observed during daylight hours assumed to be in functional operating condition. As routine maintenance inspect repair/change bulbs as needed. Best to plan for large scale replacement at roughly the time frame below for cost efficiency and consistent quality/appearance throughout client. Replacement costs can vary greatly estimates shown here are based on replacement with a comparable size and design unless otherwise noted.
