**Sunset Ridge Villas**  
**Glenwood Springs, CO**

Report #: 51217-0  
Beginning: January 1, 2025  
Expires: December 31, 2025

**RESERVE STUDY**  
**"Full"**

June 28, 2024

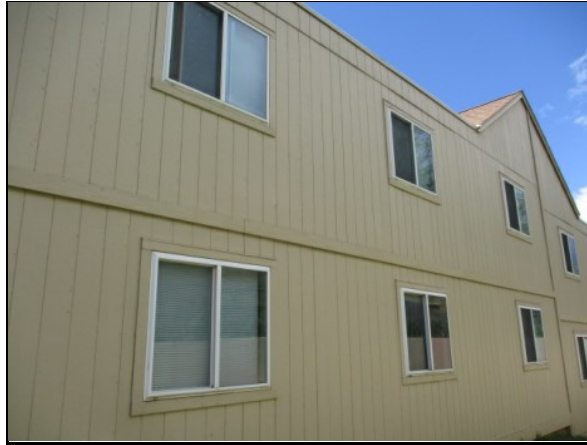
**Comp #: 23430 Windows - Replace**

Comments: Upon review of the client's governing documents individual owners (not the client) appear to be responsible for window replacement. Consult with the client's attorney to determine actual responsibility but based on our review there is no need for Reserve funding.

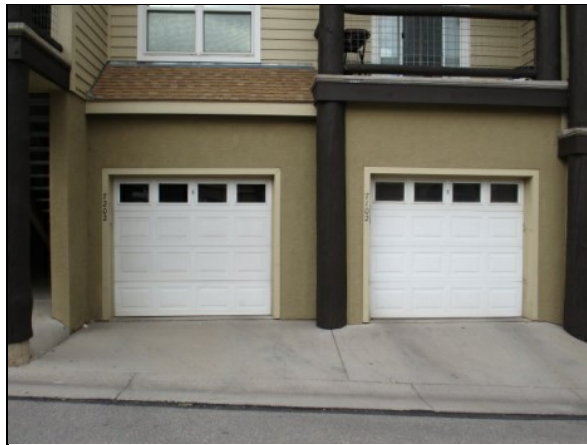
**Comp #: 23490 Ext. Garage Doors - Replace**

Comments: Based on limited review of the client's governing documents individual owners are believed to be responsible for garage door replacement. However our review is not intended to be a professional legal opinion and we reserve the right to revise this component if the client is otherwise found to be responsible for replacement. No recommendation for Reserve funding at this time.

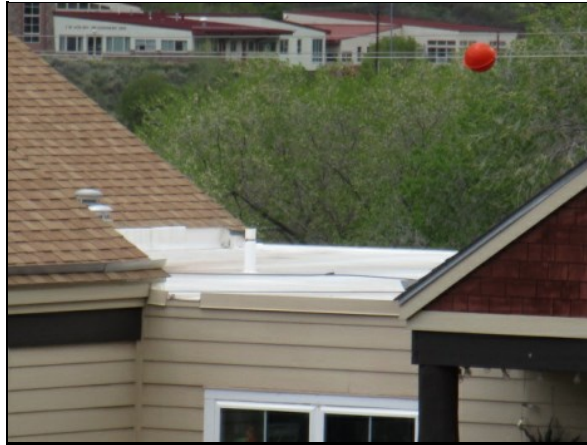
**Comp #: 23560 Roof: TPO - Replace****Quantity: ~ 18000 GSF**

Comments: Single ply roofs determined to be in poor condition and exhibit significant concerns such as advanced surface wear to membrane, punctures, lifting/separation at seams, and may also have higher incidence of bubbles/blisters that often indicate moisture is present beneath the surface. Roof is nearing end of useful life at this stage and a detailed plan for replacement should be scheduled soon, if not already in progress. Our inspection is limited to a visual evaluation of accessible areas and is not a substitute for a comprehensive inspection including destructive testing, sub-surface moisture evaluation, core sampling, etc. Typical useful life of a flat (AKA "low-slope") roof is 15-20 years depending on the quality of the roof system installed and the maintenance receives throughout its life. As routine maintenance, many manufacturers recommend professional inspections at least twice annually and after storms. Promptly repair any damaged sections or any other repairs needed to ensure waterproof integrity of roof. Keep scuppers, drains, gutters, and downspouts clear and free of debris to allow proper drainage and prevent the ponding of water on the roof surface. We recommend using walk pads or extra roofing material to provide pathways in high-traffic areas, such as around HVAC units or other equipment. Take care to minimize any penetrations in the roof system, and to properly waterproof and all drains, vent pipes, conduit penetrations, etc. For more information, we recommend consulting with independent roofing consultants or with organizations such as the Roof Consultant Institute <http://www.rci-online.org/> and the National Roofing Contractors client (NRCA) <http://www.nrca.net/>. If the roof has a warranty, be sure to review terms and conduct proper inspections/repairs as needed to keep warranty in force.

Useful Life:  
20 years

Remaining Life:  
0 years

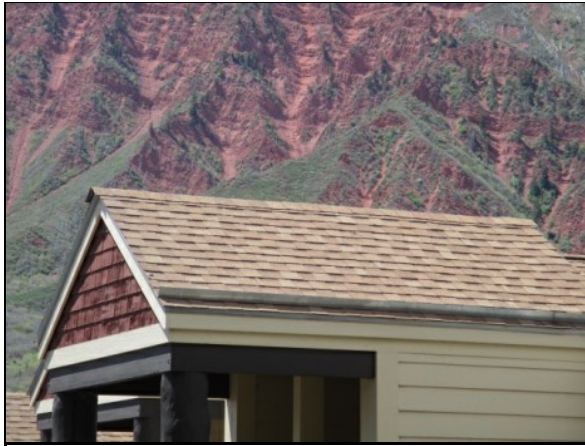
**Comp #: 23570 Roof: Composition Shingle - Replace****Quantity: ~ 17200 GSF**

Comments: Closed valleys were observed. Ventilation (the lack of which can greatly reduce the roof's useful life) was observed at the eave and ridge. Eave venting consisted of soffit holes between the rafters. Ridge venting appeared to be provided by gable end louvers and roof jacks. Debris was not observed on the roof surface. Asphalt shingle roofs determined to be in fair condition and typically exhibit normal signs of wear and deterioration including some loss of granule cover and light to moderate curling/lifting especially in most exposed areas. Overall believed to be aging normally. A reserve study conducts only a limited visual review and many of the critical waterproofing and ventilation items of the roof are not readily viewable. For a full evaluation have a professional roof consultant/contractor perform a thorough up-close survey of your entire roof system including attic inspection (if any). Costs below factors replacement with an architectural grade laminated shingle. As routine maintenance many manufacturers recommend inspections at least twice annually (once in the fall before the snow season and again in the spring) and after large storm events. Promptly replace any damaged/missing sections or any other repair needed to ensure waterproof integrity of roof. Keep roof surface gutters and downspouts clear and free of debris. At the time of re-roofing we recommend that you hire a professional consultant to evaluate the existing roof and specify the new roof materials/design provide installation oversight. We recommend that all clients hire qualified consultants whenever they are considering having work performed on any building envelope (waterproofing) components including: roof walls windows decks exterior painting and caulking/sealant. There is a wealth of information available through Roofing Organizations such as: National Roofing Contractors client (NRCA) <http://www.nrca.net>. Asphalt Roofing Manufacturers client (ARMA) <http://www.asphaltroofing.org/> Roof Consultant Institute (RCI) <https://iibec.org/rci-becomes-iibec/>

Remaining Life:

0 years
